Case Study: Furman University Charles H. Townes Center for Science

Michael Mantai, PE, LEED AP, CEM, CCP
System WorCx

Synopsis

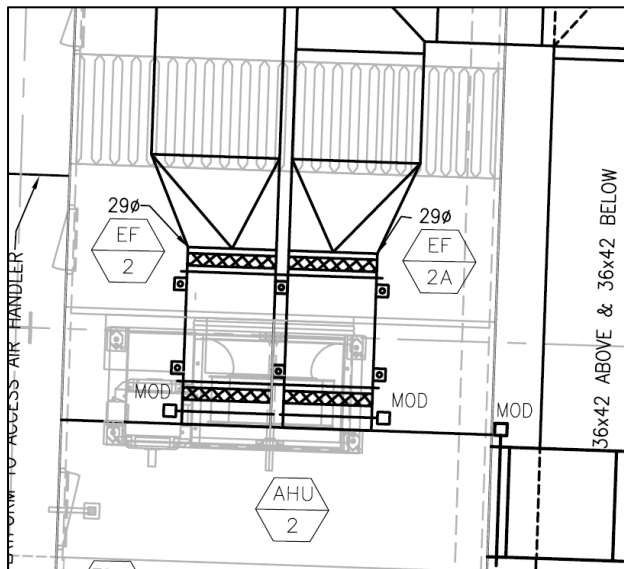
Figure A: Actual Fan Configuration

The first issue to emerge, during Test and Balance, was lack of exhaust fan capacity. The basis of design was a variable speed exhaust system which included capacity for future hoods. However, with fans running at 100% speed, design flow was not being achieved. The TAB firm reported that the fans were running at their maximum rated RPM. Investigative actions included taking duct static pressure measurements across all fittings in the exhaust duct runs to identify unexpected pressure drops, temporarily removing dampers and filters at the exhaust fans. Corrective actions included replacing some duct fittings, with marginal improvement. Below is a summary of the fan performance:

Criteria	Design	Actual
CFM	16,400	14,214
Static Pressure	6.0" w.g.	5.4" w.g.
Fan RPM	1824	1845

The fan performance was not consistent with the manufacturer's fan curves, and there was discussion about attributing this to a system effect caused by the configuration of the exhaust fans in parallel, with respect to proximity of the intakes of the fans (close-coupled installation-see figures below), and whether the fans should be rotating opposite to each other. These were more difficult to address and were not attempted to be corrected.
