Photocontrols and Daylight Savings in Sidelit Spaces

Success Factors in Design and Commissioning
Owen Howlett, Heschong Mahone Group

Sidelit Photocontrol Field Study

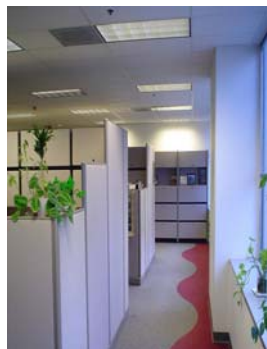
Partitions block daylight

Spaces with partitions were less likely to be functional

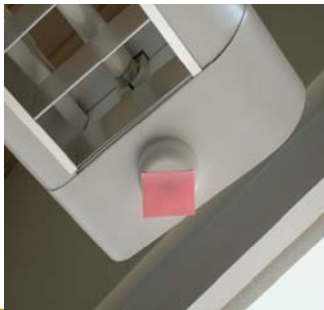
Taped-over sensor

7 spaces had failed because of taped-over sensors
