Commissioning Repetitive Floors in a High-Rise Office Building

Corporate Center
Bank of America

- 2006 Engaged for Cx
- 23 Floor Renovation
- BAC Corporate Center
- Challenges - Execution
- Opportunities for Efficiency
- Team Member Actions
- Team Member Decisions
- Success

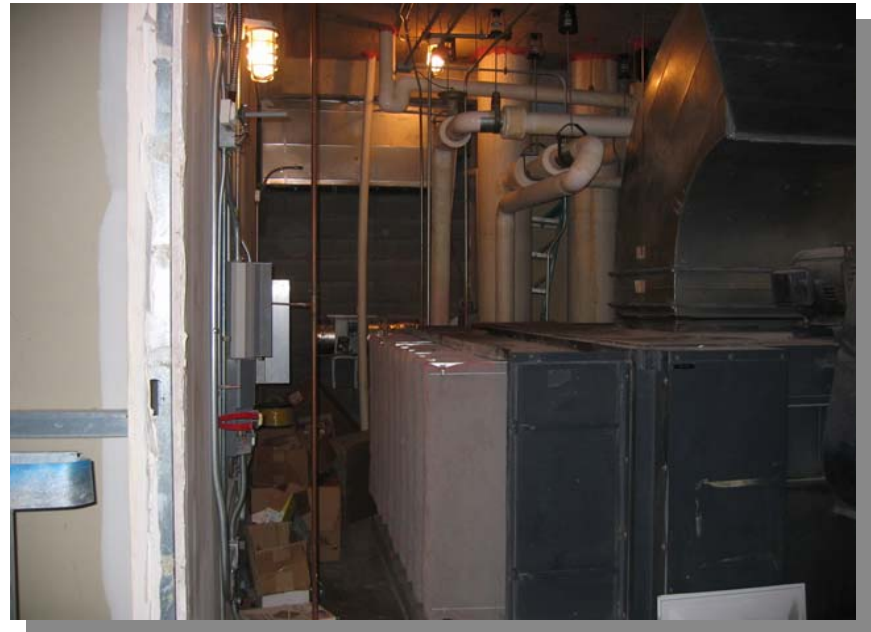
Re-use of Existing AHUs

- Less than Design Air Flow at Maximum Airflow Settings of All Terminal Units (VAVs)
- Potential for Peak Cooling Load Problems

<u>Floor</u>	<u>Design Airflow</u> (sum of air terminal units)	<u>Actual</u> <u>Measured</u> <u>Airflow</u>	<u>Deficiency</u>	
19	20,095 CFM	15,296 CFM	4,799 CFM	24%
21	22,440 CFM	15,784 CFM	6,656 CFM	30%

- Check Original TAB
- Check Flow on Unmodified Floor
- Determine Existing Fan Capacity

- Upgrade to Unit Motor Controls to VFD
 - (now inlet vanes)
- Upgrade Motor Capacity
- Remove Inlet Vanes

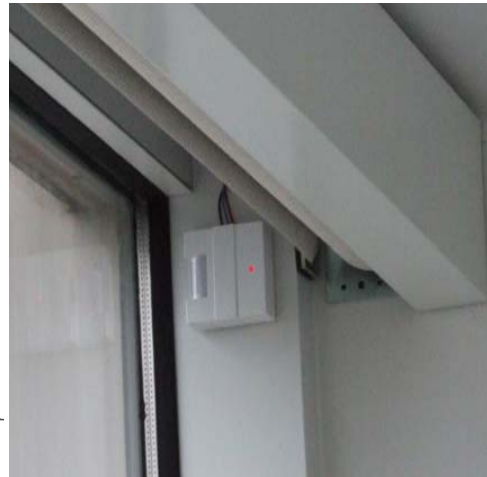
Frequency Operation

- Not Integrated
- Single Sensor per Wall
- Manual Override
- Interrupts Automation

- Reset and Increase Delay for Automatic Adjustment
- Dimming Sensitivity Reduced
- Occupant Briefings

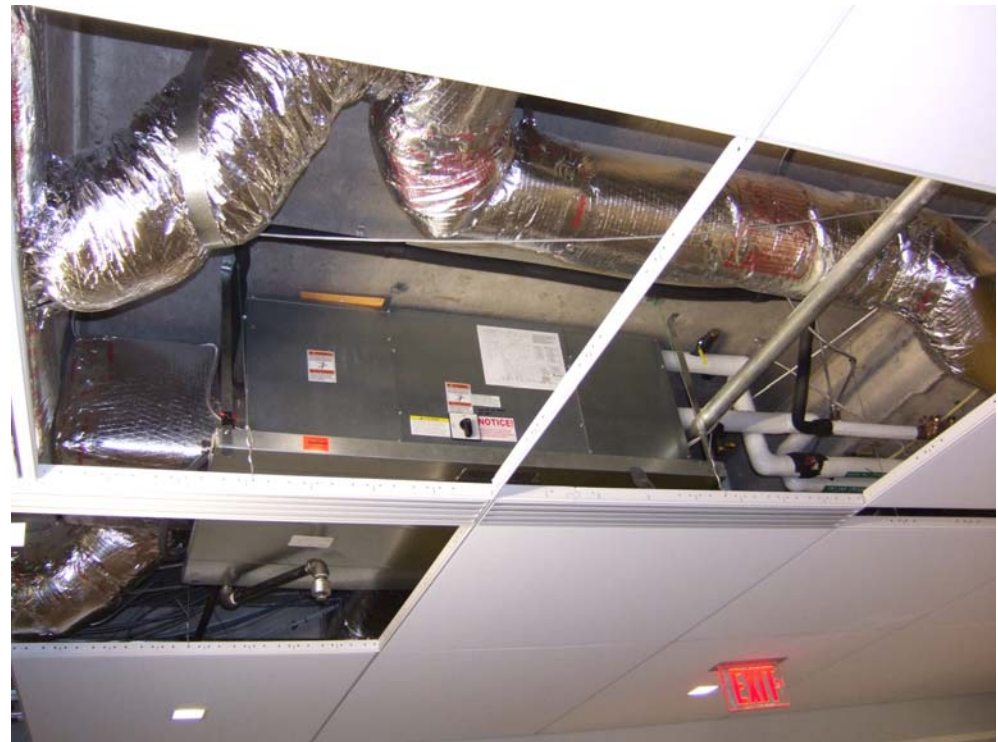
Above Ceiling Access

- Compressed Schedule
- Ceiling Closed Early
 - Sprinkler Piping
 - Access for Maintenance
 - Flexible Duct
- Ceiling 4'x4' Tiles
- Fragile

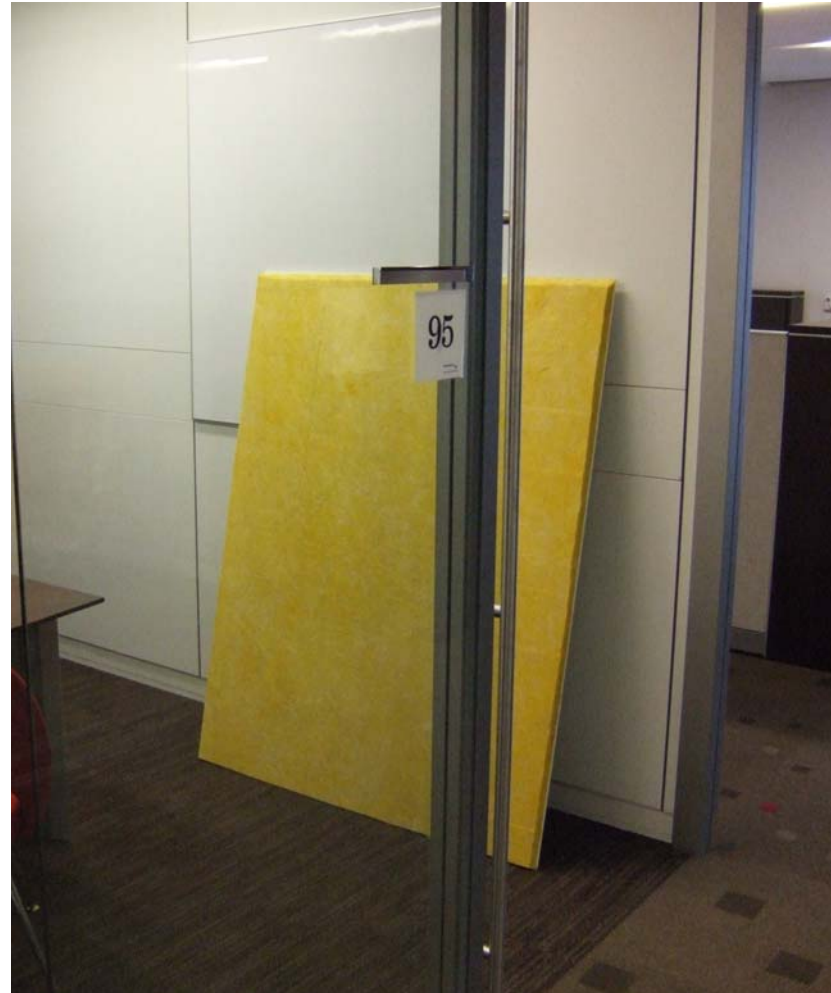
Above Ceiling Access

- Access Time Consuming and Costly
 - Broken Tiles
 - Required Ceiling Subcontractor
