## **Commissioning Repetitive Floors in a High-Rise Office Building**

### **Synopsis**

Zapata Engineering provided commissioning services to support the Leadership in Energy and Environmental Design – Commercial Interiors (LEED-CI) requirements for Fundamental and Enhanced Commissioning for the 23-floor renovation of the 60-floor Bank of America Corporate Center in Charlotte, NC. This paper describes the challenges and opportunities, and how the actions and decisions of team members contributed to project success. Challenges encountered during the project that provided opportunities for the commissioning authority included: the commissioning agent joined the team late in the design development phase; a compressed design and construction schedule required simultaneous activity on multiple floors; the complexity of paperwork tracking for simultaneous, multi-floor recordkeeping; and, limited input to the construction schedule. Efficiencies planned into the project from inception that furthered project success included: Owner selected team members who had worked together previously; architect’s “chassis design” provided a common mechanical, electrical and plumbing foundation for each

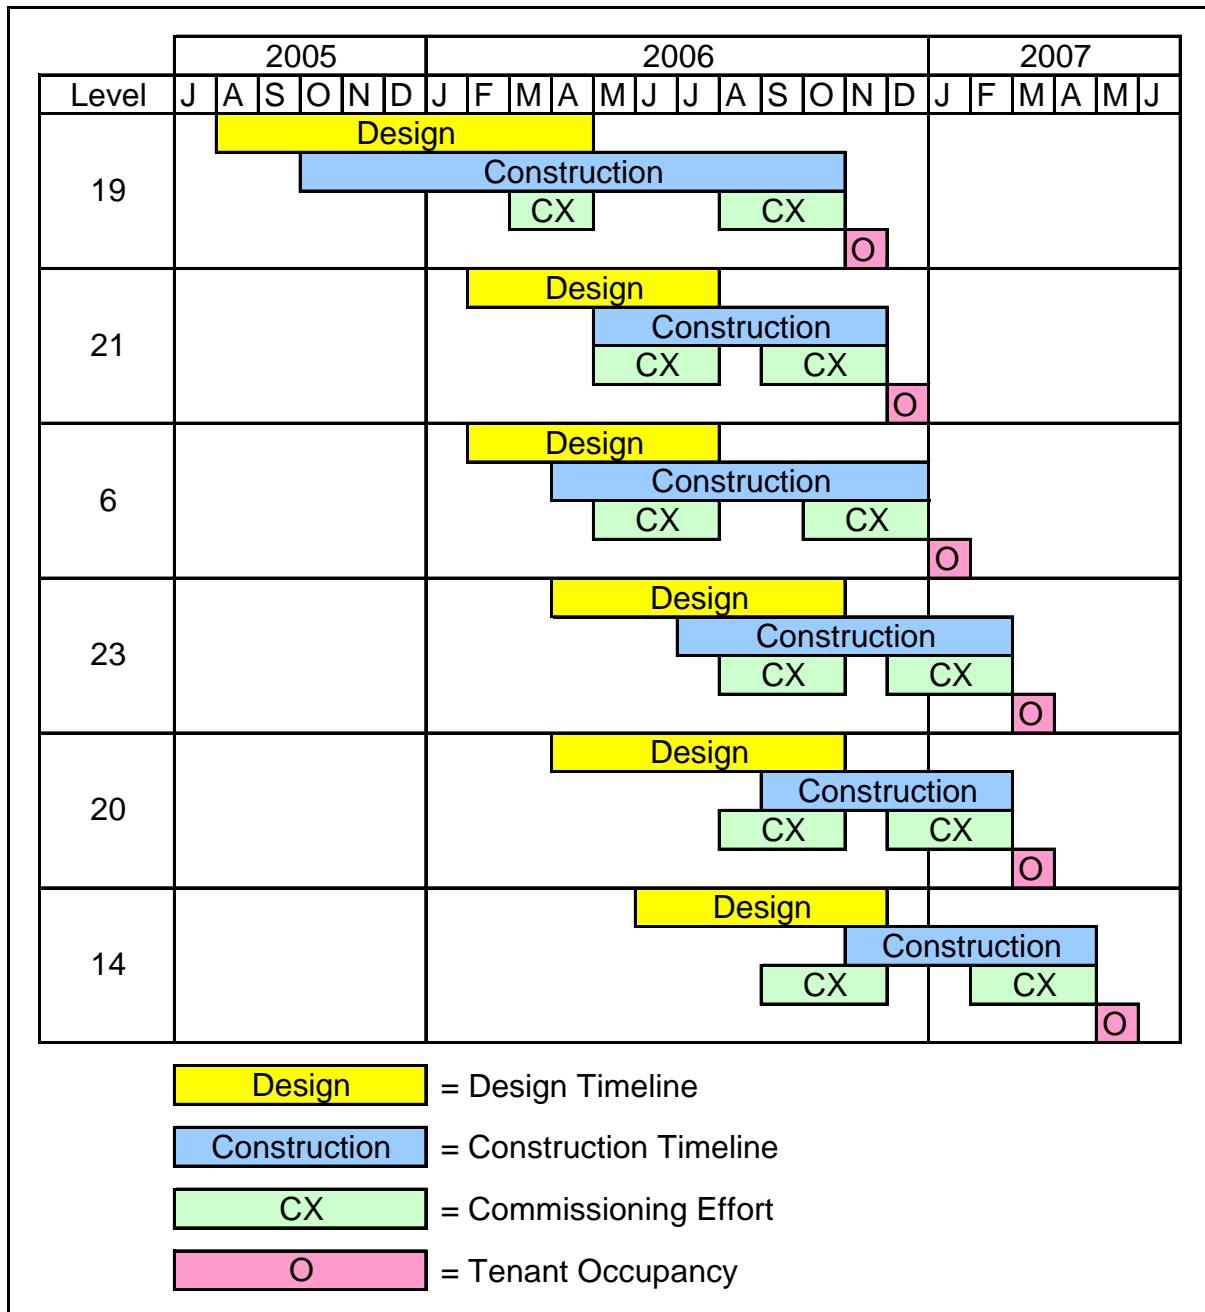
A compressed design and construction timeframe required simultaneous activity on multiple floors and presented both scheduling and recordkeeping challenges. In an effort to be as efficient as possible, the design and construction team kept work crews always busy through a staggered schedule. Figure B represents some of the critical dates showing the overlapping and simultaneous actions being conducted on multiple floors of the building.

**Figure B: Gantt Chart Depicting Similtaneous Scheduling**

As anyone involved with commissioning knows, the ability to document all actions is key to providing quality service that can withstand a USGBC audit. The complexity of paperwork tracking for simultaneous, multi-floor recordkeeping has been and still is a challenge. As shown in Figure B, it is entirely possible to be conducting a DD review of one floor, a prior-to-construction document (CD) review on another, writing a commissioning plan for upcoming floors, conducting pre-functional testing on one floor and functional testing on another. During one site visit, the commissioning agent must be conversant on issues on multiple floors and in

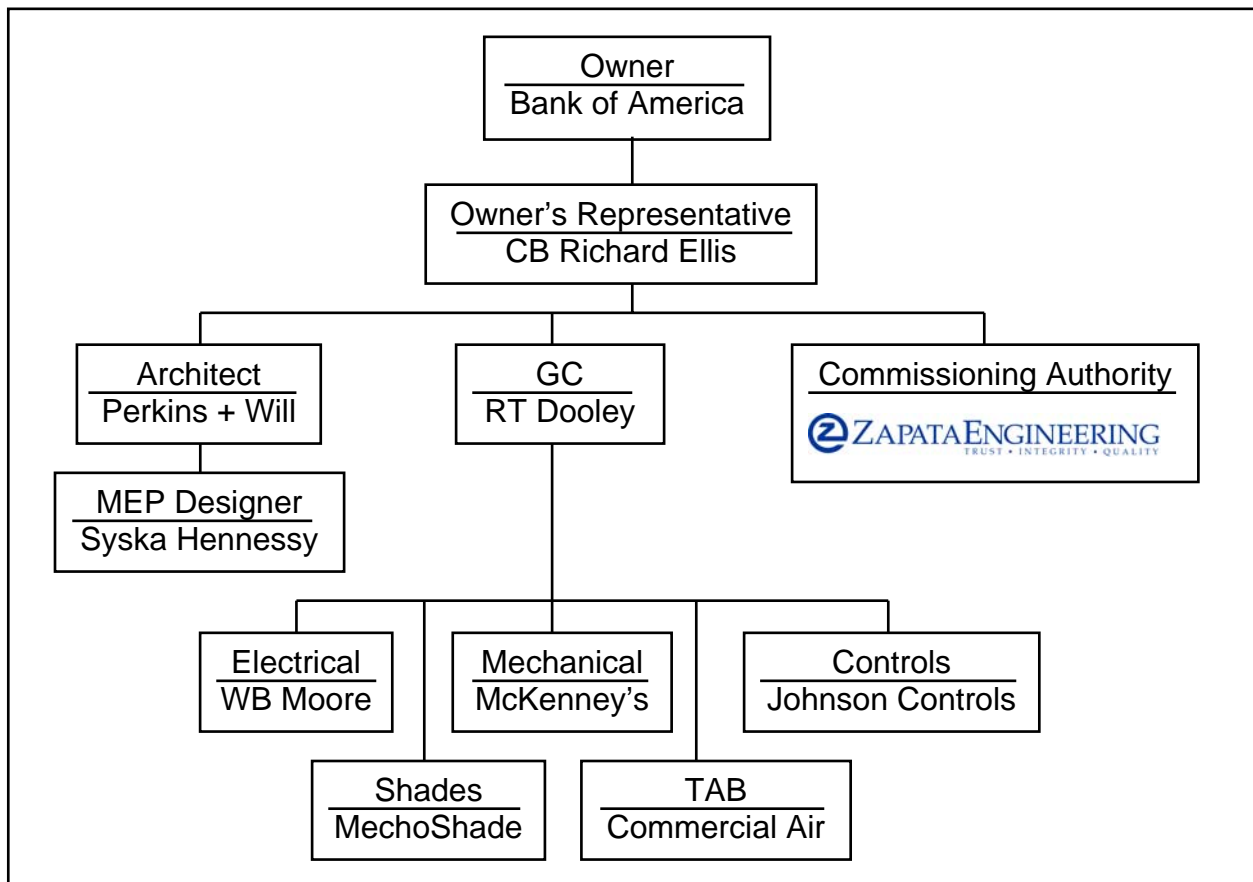
A major factor contributing to the success of this project, was that teamwork and communication were enhanced by the owner's decision to select team members who had worked together previously on other projects for the owner. Figure C depicts the members of the project team that were involved in the commissioning process. Almost all members of the team had worked together before this project developed. This included the owner, owner's representative, architect, MEP designer, general contractor (GC) and the commissioning authority. All of the subcontractors had worked for the GC before.

**Figure C: Project Team Relationships**

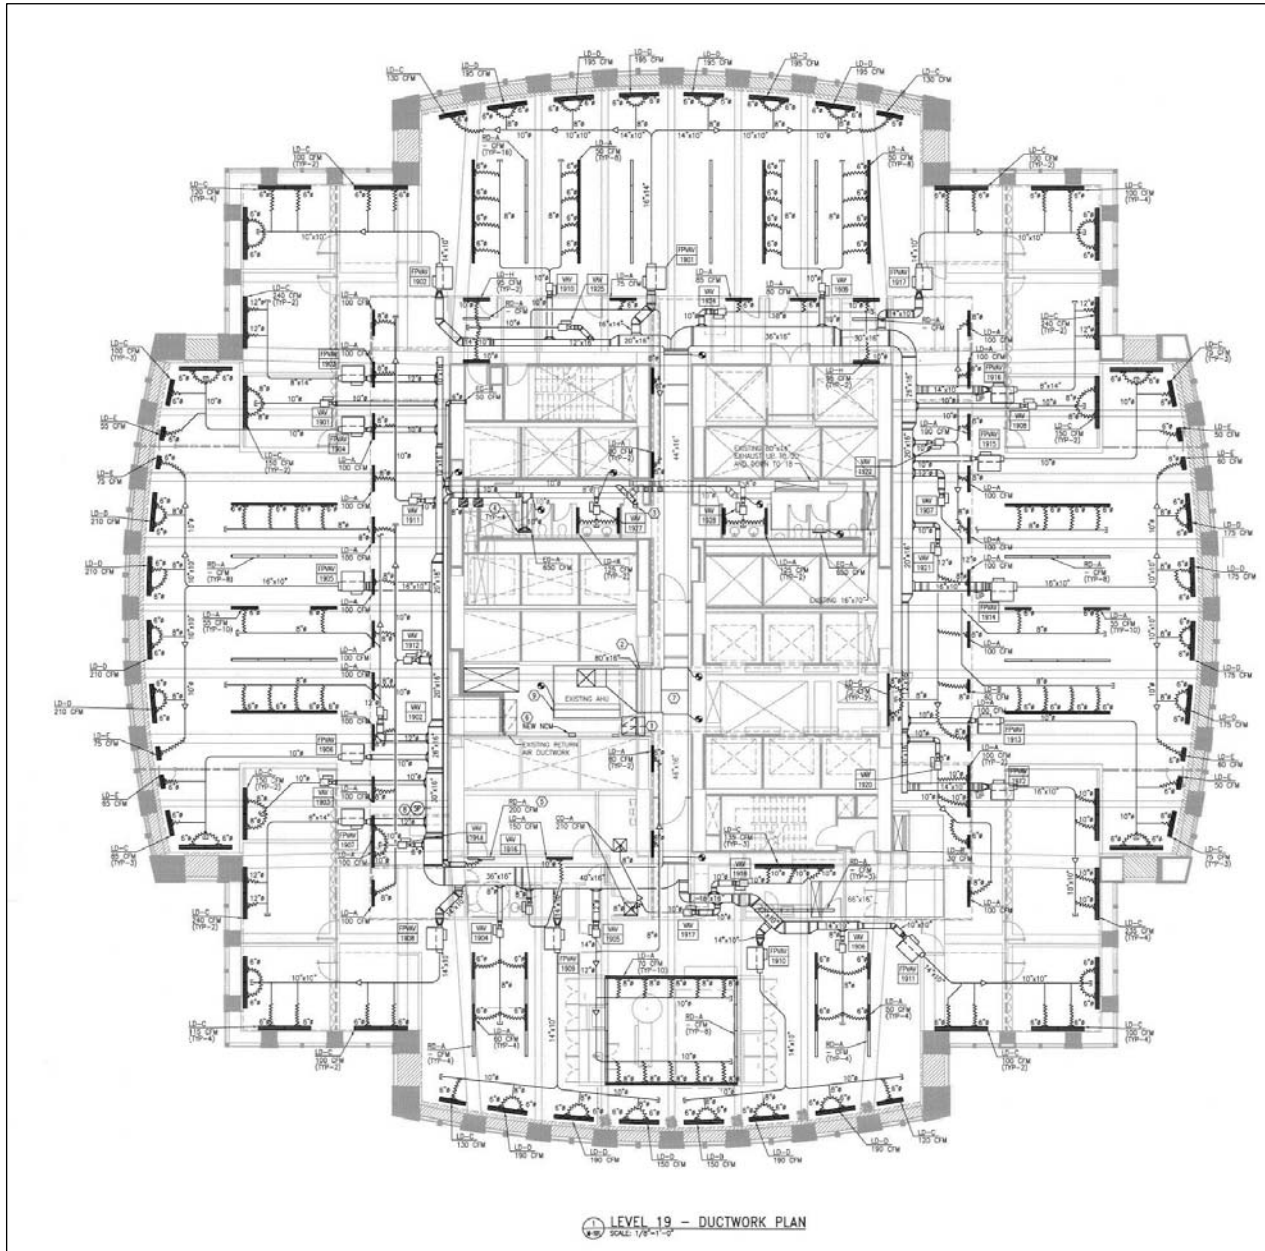
Chassis Design - Efficiencies were facilitated by the architect's "chassis design" that provided a common mechanical, electrical and plumbing foundation for each floor's renovation. This factor significantly assisted in speeding the process along after completion of the first floor. Since each floor had a similar basic design, for subsequent floors, we knew what worked and what did not work. This sped the design reviews, allowed for increasing capability through the learning curve; and allowed improvements and incorporation of design changes and construction processes. Each floor has common systems for electrical, HVAC and plumbing.

Figure D: Example of the Chassis Design from Level 19 - Mechanical

Grouping of Floors - This chassis design resulted in the grouping of floors for efficiency of effort; facilitated sequencing of work; and simplified review of submittals and conduct of pre-functional and functional testing. This allowed for demolition to significantly proceed the renovation start to eliminate delays. The grouping allowed for the entire team to focus on the immediate issue at hand and then share the solutions to those issues immediately on the next floor. This allows for common O&M Manuals, common training, and common recordkeeping documents.
